# ARCHITECTURE

STUDY BY: POPULOUS

# THE 'K' - CURRENT STATE

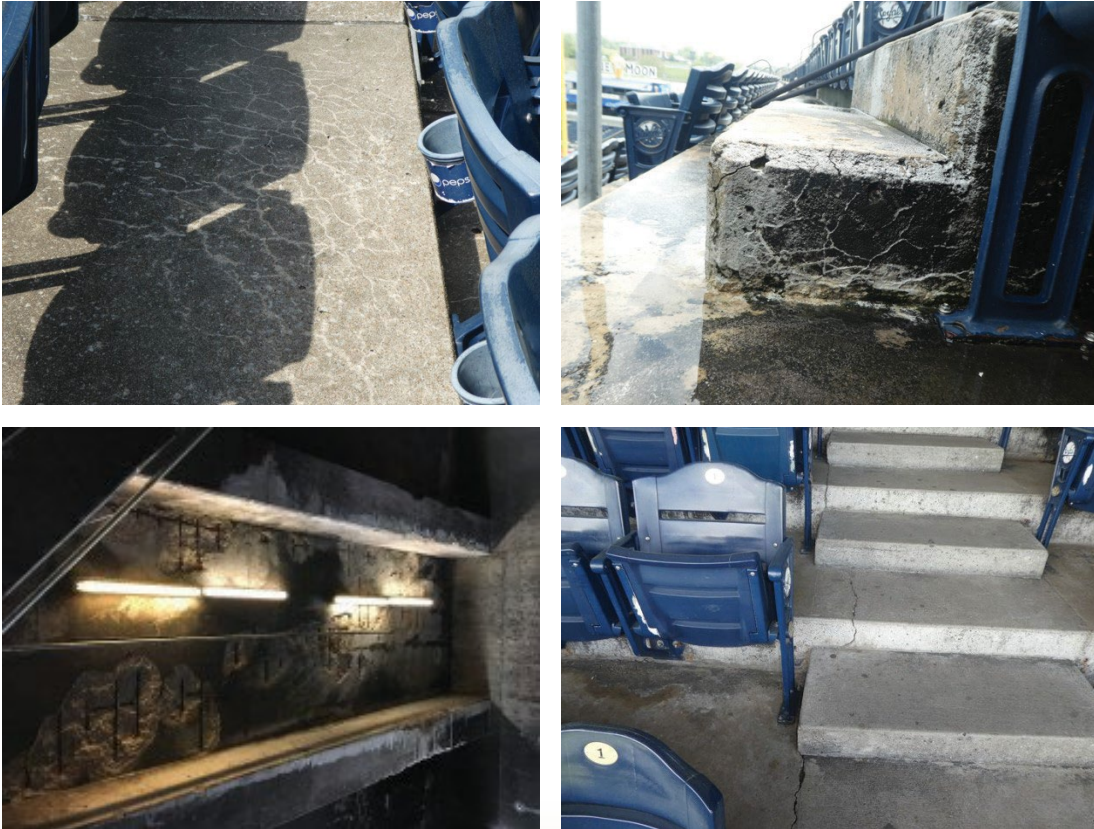
## ASR (Alkali-Silica Reaction)

- Commonly known as concrete cancer; its presence in the concrete at Kauffman has been confirmed with observations and testing.
- Reactive silica is present in the aggregate used, which reacts with the alkali hydroxide in the concrete to form a gel that expands as it absorbs water, which over time causes cracking, spalling and deterioration of the concrete at a rate much faster than typical concrete wear.
- There is evidence of ASR throughout the structure, which eventually results in replacement.

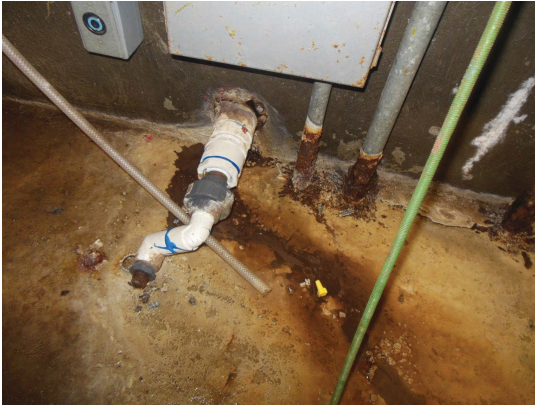
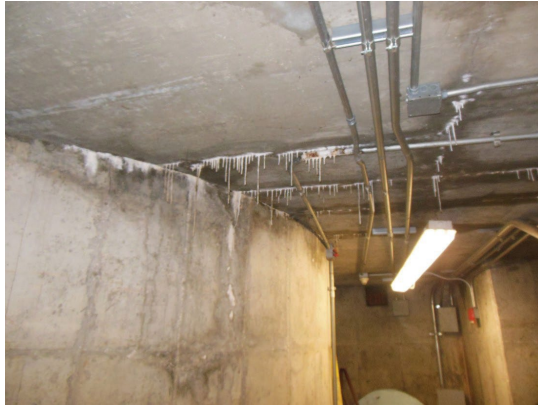
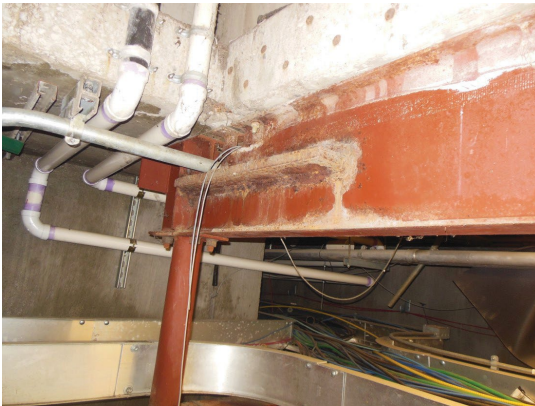
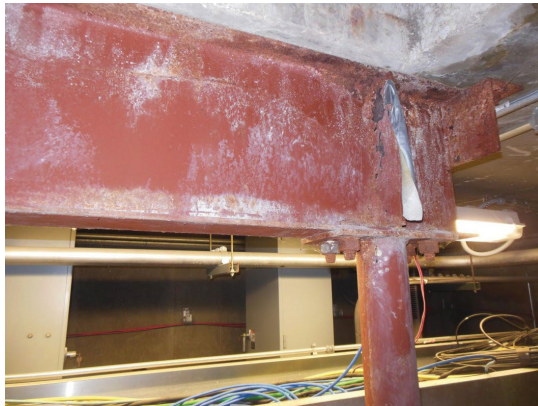
## Fountain & Pump Room

- Evidence of breach in waterproofing of the fountain walls and slabs, allowing water to leak into the pump room which is located adjacent to the lower level of the fountain and below the upper level of the fountains.
- Resulted in deterioration of the concrete and corrosion of steel.

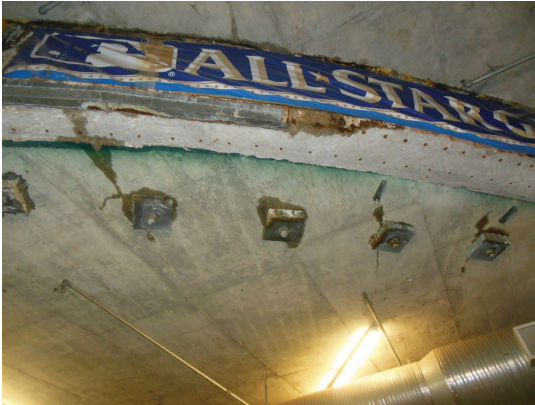
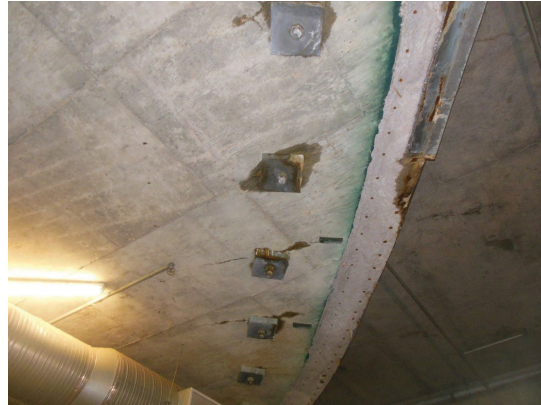
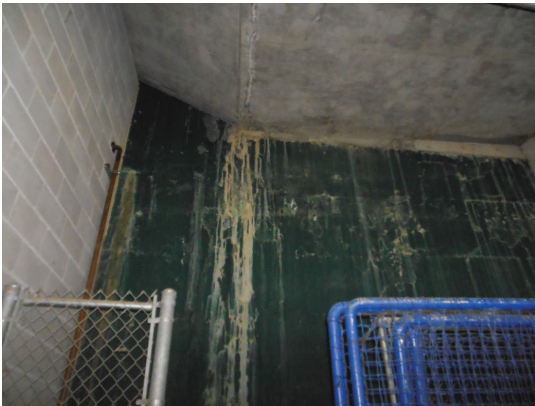
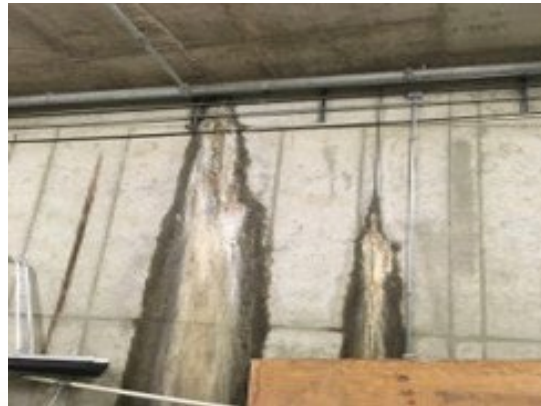
## Right Field Service Tunnel

- Concrete cracking, spalling and rusting of hanger rods.
- Rods are the elements hanging from a large concrete transfer beam above the lid which assist in supporting the concrete at the concourse spaces above.

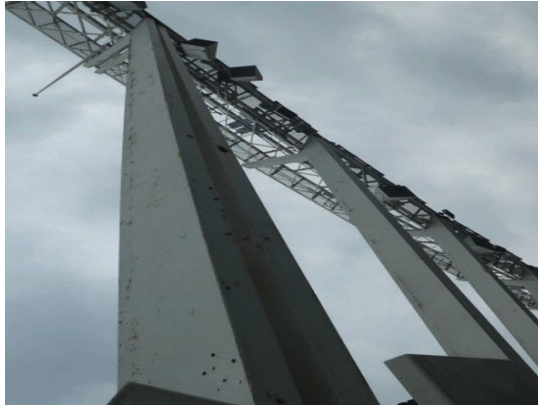
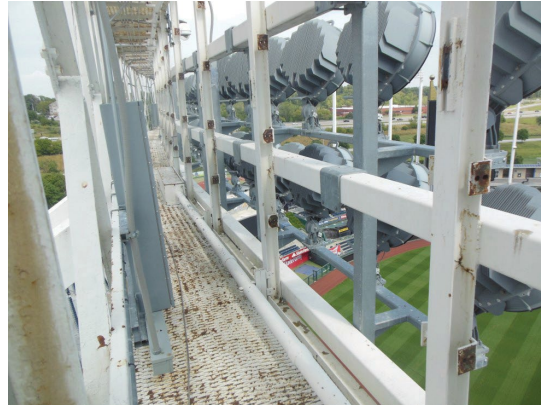
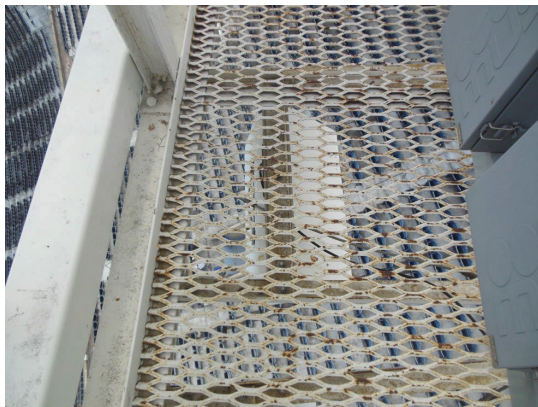
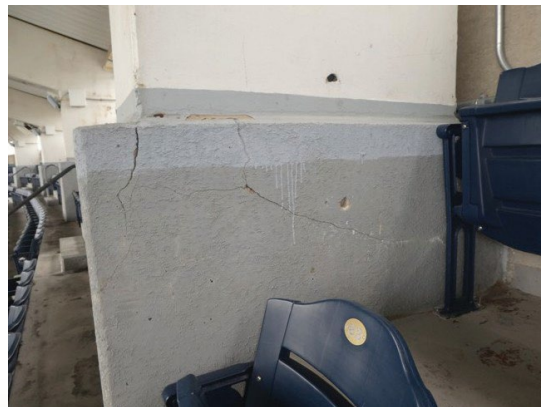
## Canopy Steel & Light Towers

- Steel rusting and cracking of concrete support pedestals.
- At the outfield light towers, overall rusting throughout is evident on the outside and water can ingress from the open top (used for access to the lighting catwalk), which collects inside at the base and is rusting the base steel from inside out.

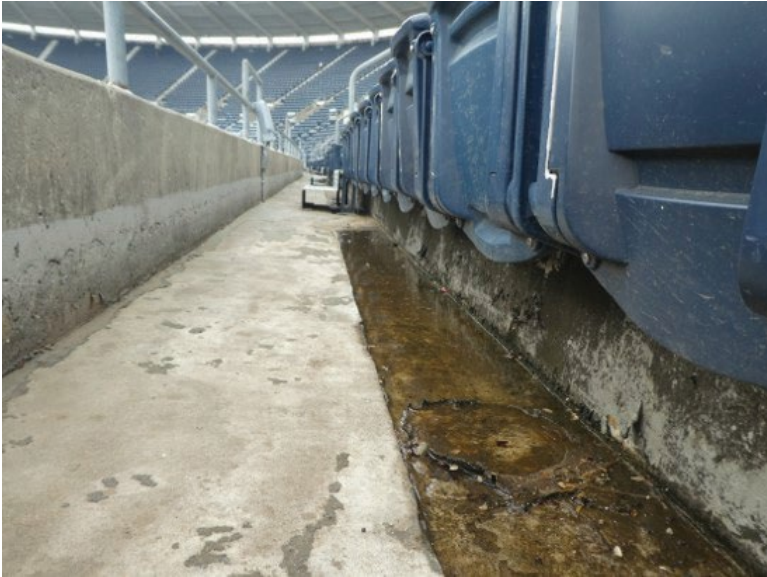
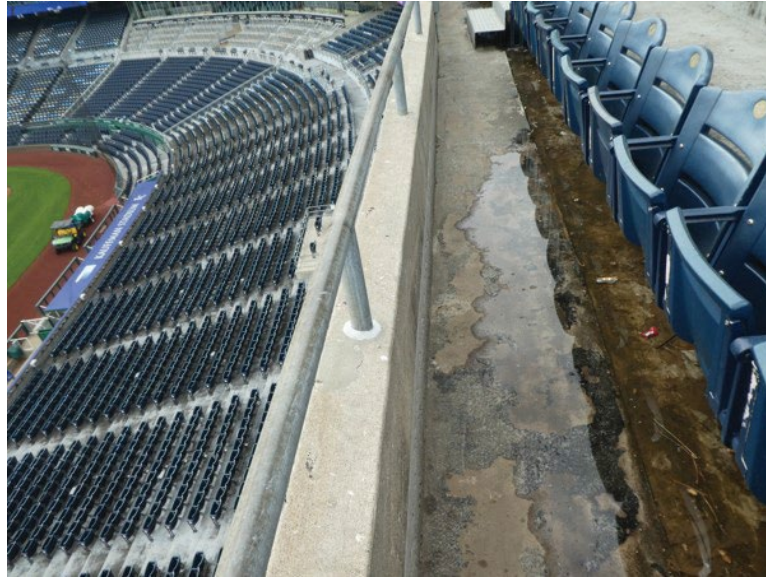
## Upper Deck Front Tubs

- Inadequate drainage and ASR corrosion.
- Numerous ASR related repairs performed with the 2007-2009 renovation. There is evidence of additional issues since that time.
- Will need to replace for extended life expectancy.

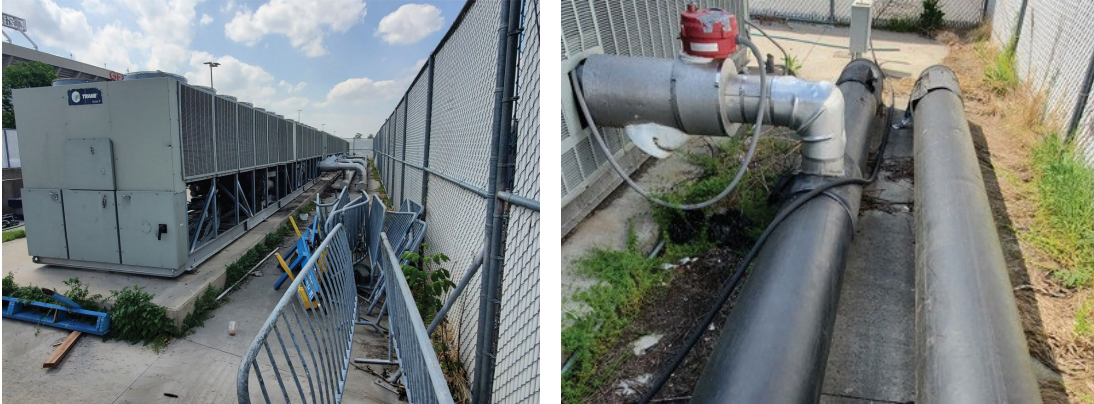
## Stadium Chilled Water System

- The main stadium cooling loads are primarily served by an air-cooled chiller plant located in an MEP yard south of the stadium.
- The plant consists of (2) 500T chillers and (1) 200T chiller. The larger chillers are 13 years old and nearing the end of their expected life (15-20 years).
- The smaller chiller is from the pre-2009 renovation and is well past its expected life.
- Replacement of all (3) chillers is imminent and would include replacement of the chilled water piping from the chillers to the stadium.

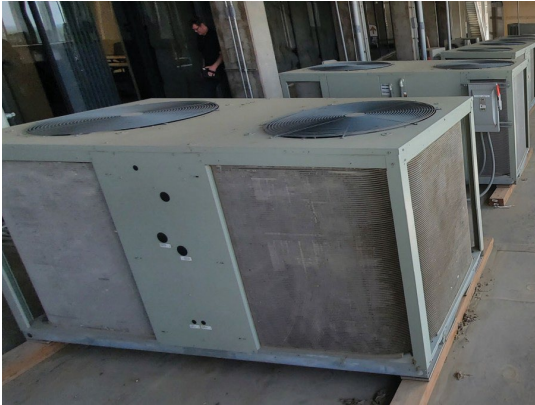
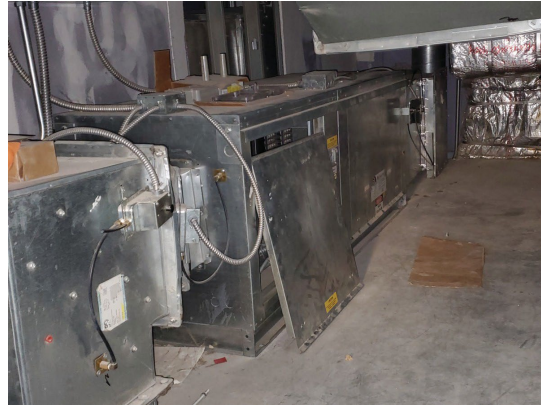
## Stadium Heating System

- The majority of the conditioned stadium spaces are heated with electric heat via indoor AHUs or rooftop units (RTUs) with electric heating coils.
- Generally considered a good first-cost solution but is a long-term higher utility cost without other means of site-generated power (e.g. solar panels).
- Energy generation and conservation measures are typically implemented in a new building (or major renovation) to maximize system efficiency and to minimize the annual operational costs.

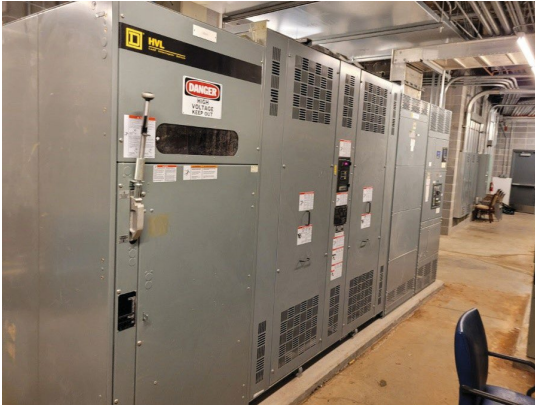
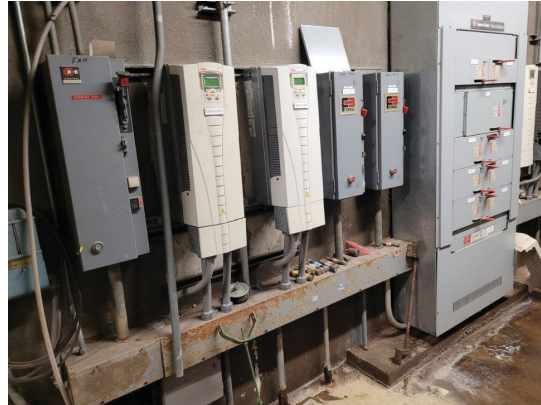
## Electrical Distribution System

- Service life of the major electrical distribution equipment and circuit breakers will expire by the end of this decade (requiring replacement of the gear and components at that time).
- Current system is deficient in service redundancy and reliability compared to modern MLB facilities, requiring additional unit substations and electrical services. Space required to upgrade is not available on the Service Level.
- The distribution system at the fountains is in more immediate need of replacement due to its environment and age of equipment.
